ENVIRONMENTAL ASSESSMENT
CLEARWATER FISH BARRIER
MODIFICATION/REMOVAL
MISSOULA COUNTY, MT

| ENVIRONMENTAL ASSESSMENT CLEARWATER FISH BARRIER MODIFICATION/REMOVAL MISSOULA COUNTY, MT | ALTERNATIVE 2 CONCRETE REPLACEMENT | FIGURE 2-1 |

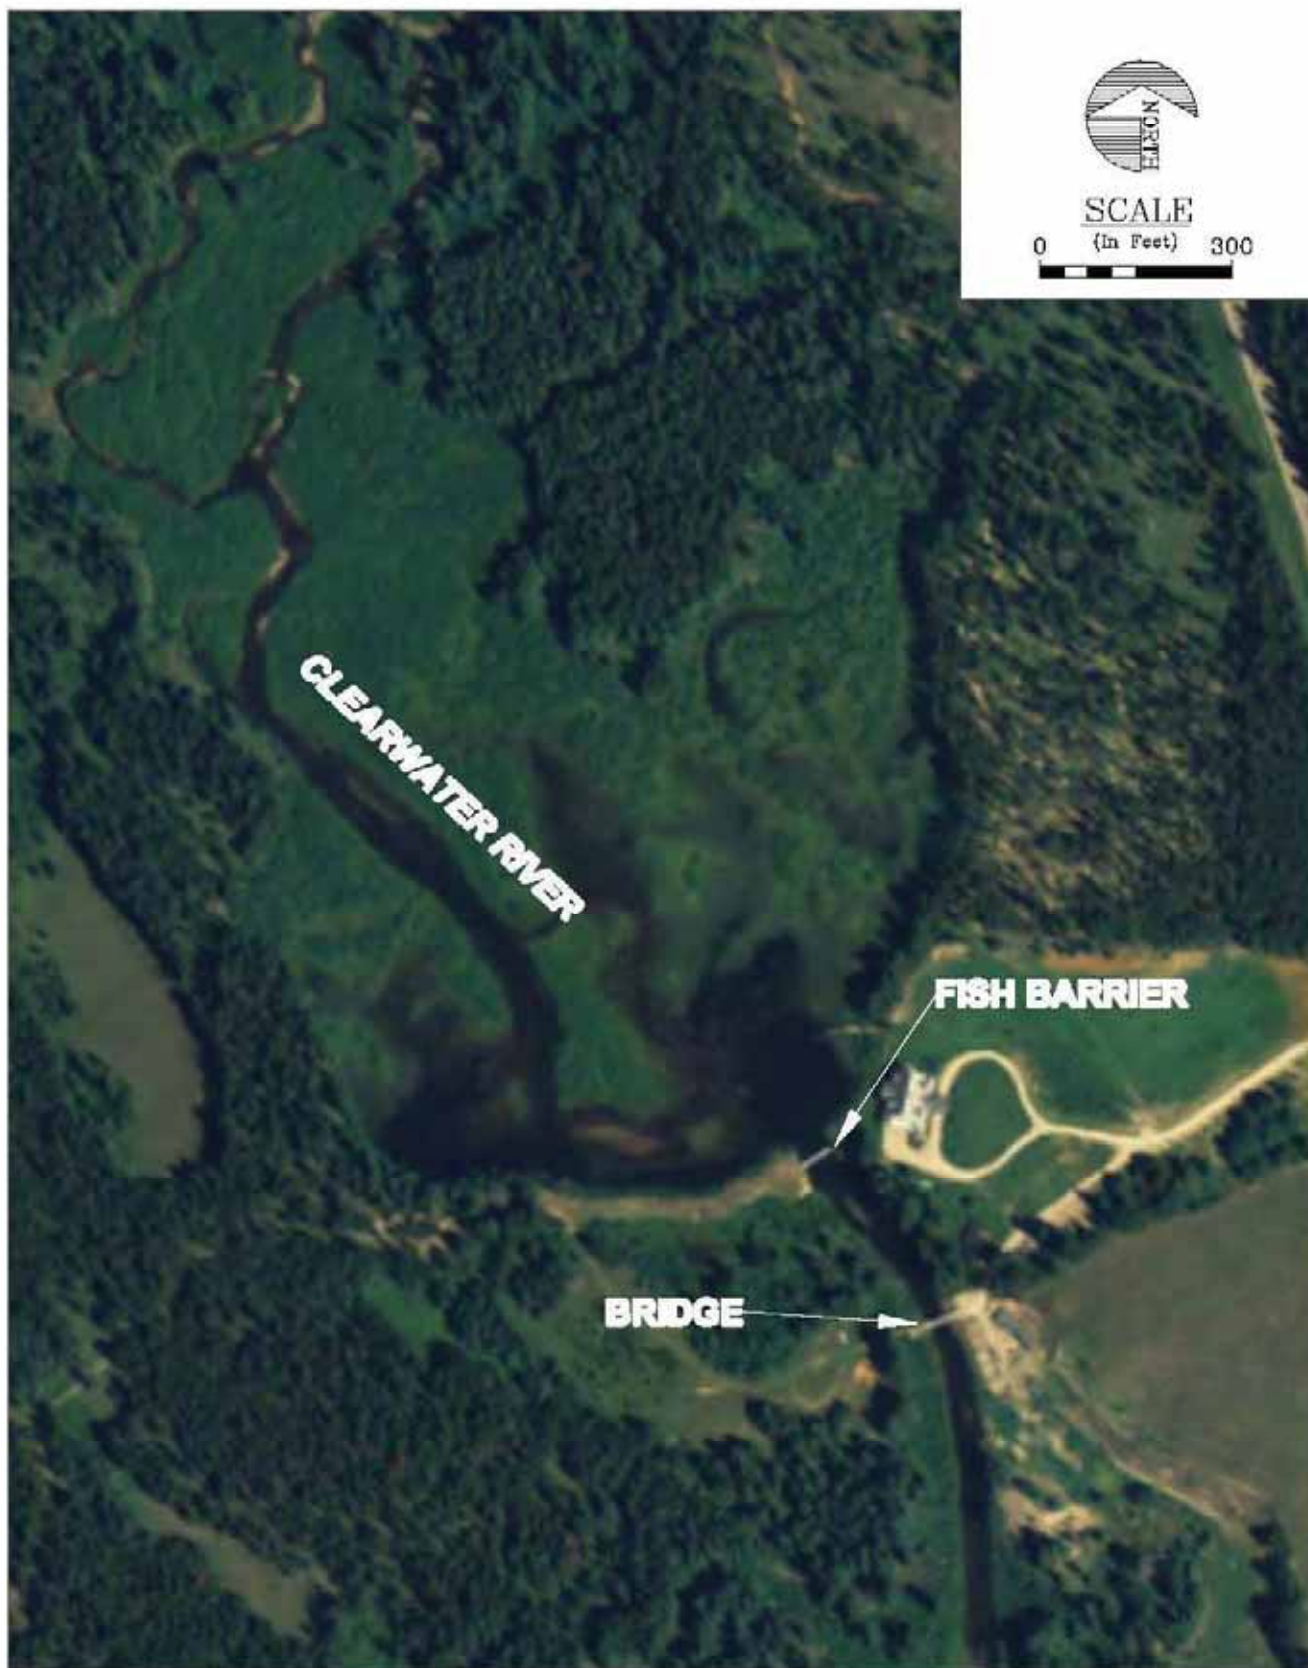
1-2

SITE OVERVIEW
